Wear Resistant Coatings for Titanium Alloys

fretting fatigue of uncoated Ti-6A1-4V

General Electric Company

Technical Report AFML-TR-71-212

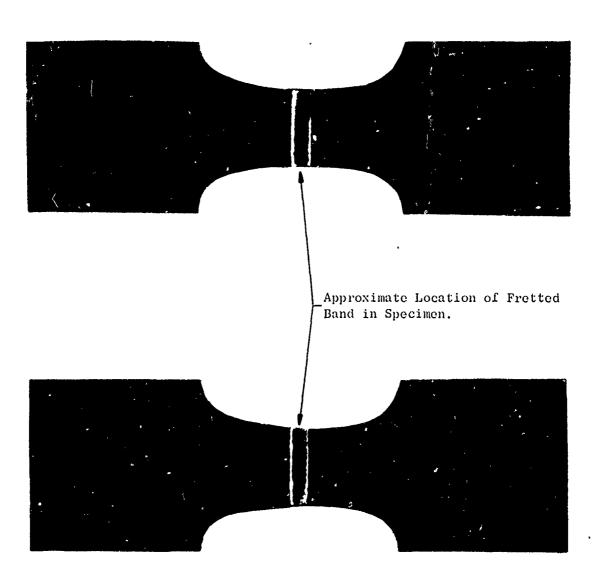
Figure 21. Autoradiograph Exposures of Kryptonized Fretted Specimens.

The Fretted Bands were Effectively Outlined by the Method, but Crack Detection was Difficult. (Industrial Nucleonics)
